Manhole Inspection Summary

Manhole # S21GG1018MH

Insp Date: **7/27/08 10:35 PM**

Location Address: **1453 MEDFIELD AVE**

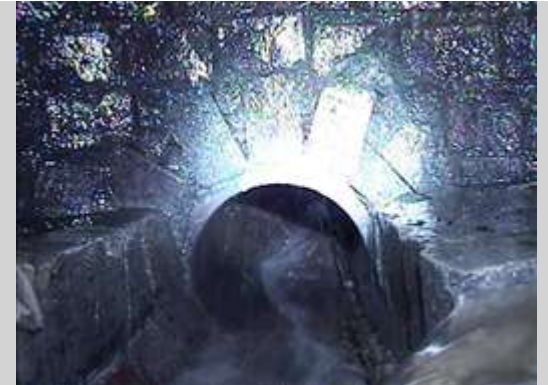
8 in. Circular Gravity Sewer Pipe Out @ 12 O'Clock

Invert Depth: **13.33** (ft.) Flow Characteristics: **Fast**

Deposits: ☒ None ☐ Mud ☐ Sludge ☐ Debris ☐ Grease

Infiltration: **None** Pipe Seal Cond: **Unknown**

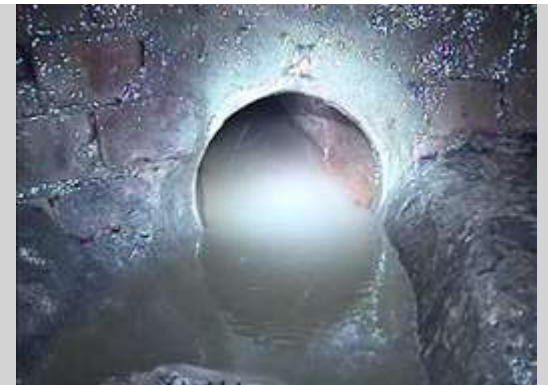
8 in. Circular Gravity Sewer Pipe In @ 4 O'Clock

Invert Depth: **12.73** (ft.) Flow Characteristics: **Slow**

Deposits: ☒ None ☐ Mud ☐ Sludge ☐ Debris ☐ Grease

Infiltration: **None** Pipe Seal Cond: **Unknown**

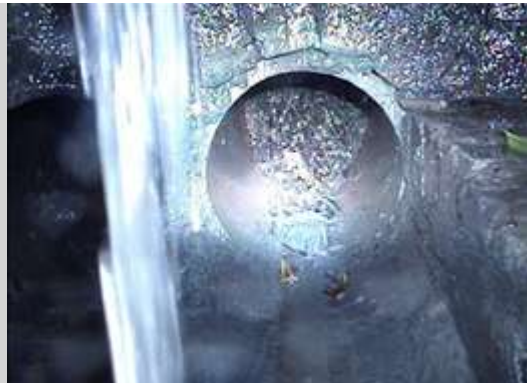
Pipe In @ 6 O'Clock

Infiltration: **None** Pipe Seal Cond: **Unknown**
